Emergency Restoration of Trout Spawning Beds

By Thomas W. Amidon, Senior Associate
Omni Environmental LLC
www.Omni-Env.com

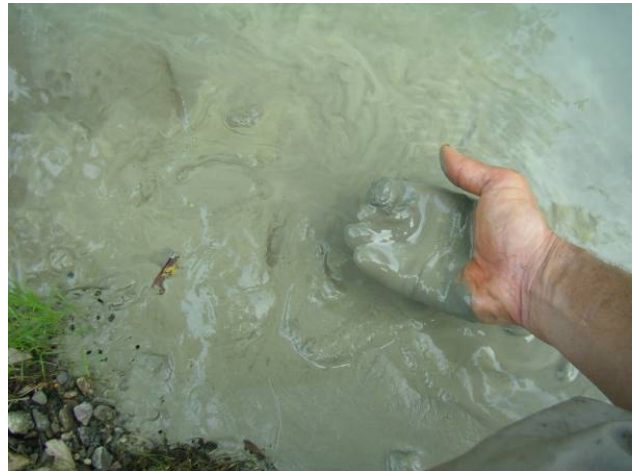
An active quarry immediately upstream and within the same sub-watershed experienced a catastrophic failure of one of its settling basins. The failure resulted in the discharge of rock dust slurry into a tributary containing trout spawning beds and eventually emptying into the main trout stream. A representative from NJDEP Water Compliance and Enforcement visited the site to inspect the damage the day after the spill was reported. The State concluded that there had been a spill, but that no remediation measures would be necessary. From a strictly water quality perspective, the inspector was correct. The rock dust slurry had settled to the stream bottom, and would eventually pass through the stream to the downstream reservoir, where it would settle to the bottom permanently and pose no instream water quality hazard.

However, the slurry formed a 6-to-12-inch-thick sludge in places, and coated the entire bed of the tributary as well as a portion of the main stream. The fall spawning season was less than three weeks away, and the fishing club and its consultant (Omni Environmental LLC) recognized that a significant portion of the spawning beds would be destroyed. Furthermore, the process of allowing the material wash out naturally would take at least a few months and result in even greater damage to downstream beds between the tributary and the reservoir. The

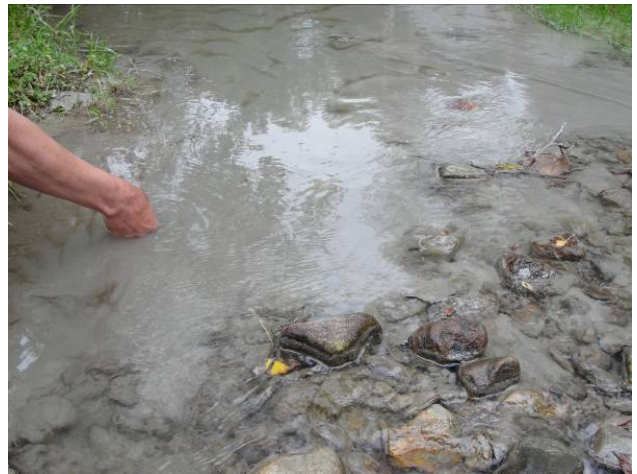
As soon as it became clear that the discharge had degraded the spawning beds, the quarry owner immediately performed interim emergency actions to remove the source material at the point of discharge, stabilize the source area, and prevent further slurry migration. Under the direction of Boswell Engineering¹ (Boswell), the quarry owner installed silt fencing and removed the bulk of the source material by hand. The washed out area immediately downstream of the breached sedimentation basin was seeded and stabilized with hay. Finally, hay bale sediment barriers were installed at strategic locations along the affected tributary as well as the main stream channel to prevent the degradation of additional spawning beds downstream of the areas already affected.

With the interim emergency measures in place, Boswell, on behalf of the quarry, began to develop a final remedial approach for this environmentally sensitive area. Boswell worked closely with the various NJDEP enforcement offices as well as Omni to develop an overall remediation strategy that would remove the slurry from the tributary and stream without harming the stream bed. In this situation, the

greatest challenge was to ensure the remedial solution was not worse than the problem itself – in other words, to “DO NO HARM.” Boswell devised an innovative and effective solution using a low-pressure wash combined with a low-velocity vacuum to gently remove the slurry. The channel was segmented into workable reaches with the hay bale sediment filters, and each reach was restored individually according to the sensitivity of the aquatic biota present within the channel. The highly labor-intensive work proceeded using a sequential phased approach, proceeded incrementally downstream from the tributary to the stream in individual segments. During the restoration, nearly all water (and suspended material) in the tributary was collected downstream and pumped up to a basin on the quarry property. Downstream of the pump, stone filter berms were installed in the tributary on either side of the road culvert, and additional hay bale sediment filters within the main stream channel were used to minimize migration while the final low-velocity vacuuming was performed.
